**COMMERCIAL WINDSTORM MITIGATION REPORT (OIR-B1-1802)**

Indian Springs Condominiums, Inc.

14800 Walsingham Rd, Building 7

As of 3/11/2020

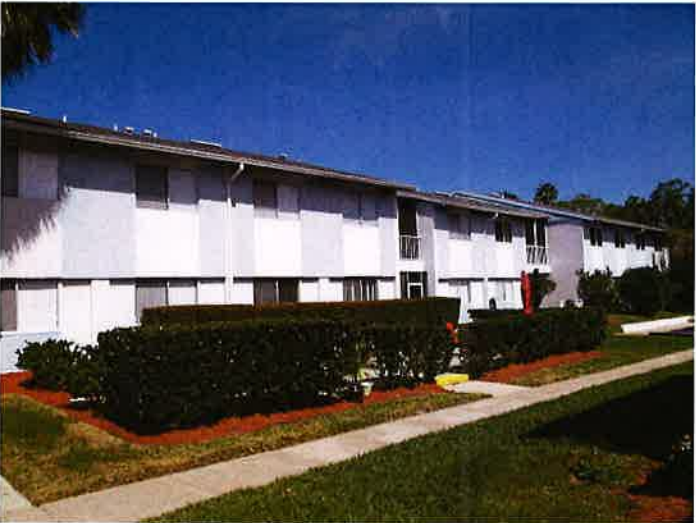
Exterior Elevation

5. **Roof Geometry:**                      **Other Roof**  
Comments:                                      Inspection verified a gable roof shape.
6. **SWR:**                                      **No**  
Comments:                                      Inspection verified no secondary water resistance.

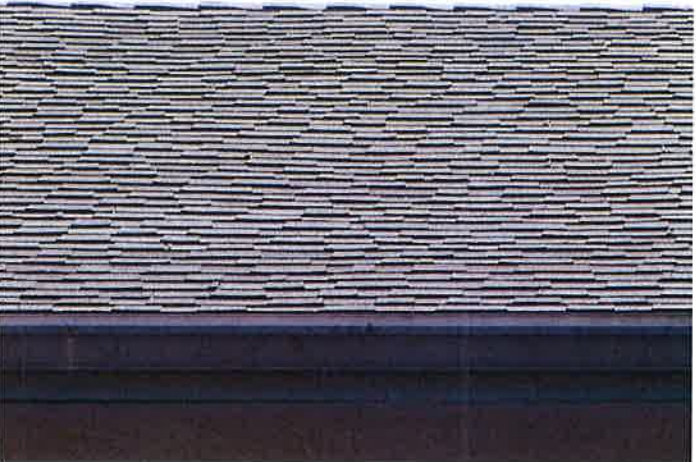
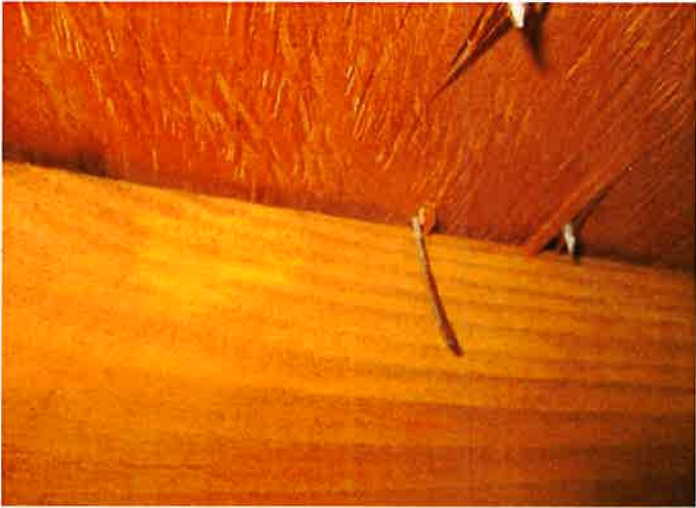
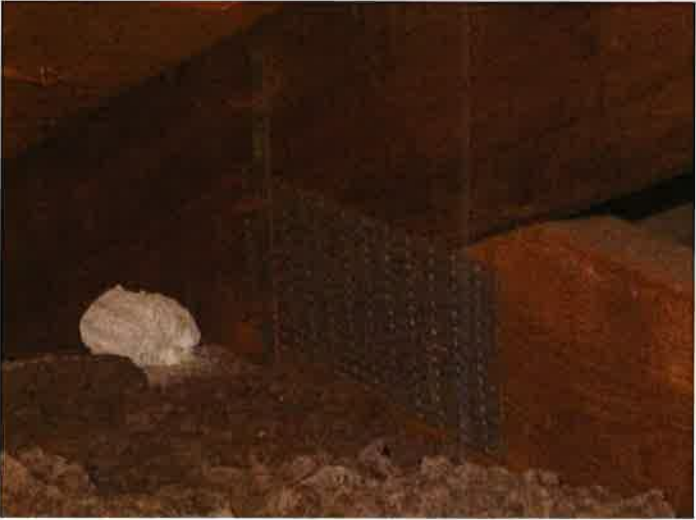
Roof Construction

3. **Roof Deck Attachment:**        **Level A**  
Comments:                                      Inspection verified 1/2" plywood roof deck attached with staples at a minimum of 6" on the edge & 12" in the field.

4. **Roof to Wall Attachment:**        **Clips**  
Comments:                                      Inspection verified embedded straps fastened with a minimum of three nails.
