COMMERCIAL WINDSTORM MITIGATION REPORT (OIR-B1-1802)

Indian Springs Condominiums, Inc.

14800 Walsingham Rd, Building 8

As of 3/11/2020

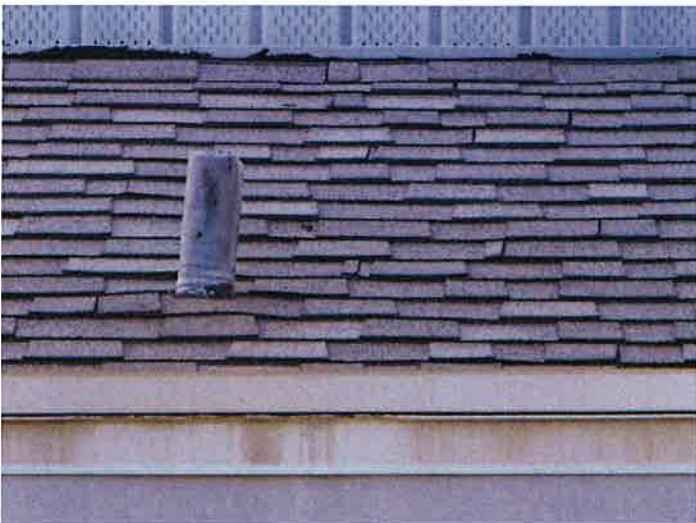
Roof Construction

- 3. Roof Deck Attachment:** **Level A**
Comments: Inspection verified 1/2" plywood roof deck attached with staples at a minimum of 6" on the edge & 12" in the field.

- 4. Roof to Wall Attachment:** **Clips**
Comments: Inspection verified embedded straps fastened with a minimum of three nails.
- 5. Roof Geometry:** **Other Roof**
Comments: Inspection verified a gable roof shape.
