COMMERCIAL WINDSTORM MITIGATION INSPECTION REPORT (OIR-B1-1802)

Indian Springs Condominium Association Inc
14800 Walsingham Rd (Building 9)
Largo, FL 33774

As of 6/23/2015

FPAT File #MIT158533

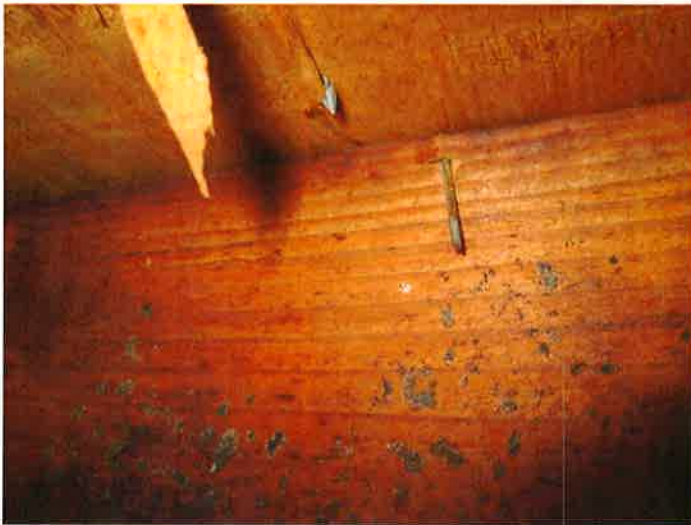
Roof Deck Attachment
(Section 3)

3. **Roof Deck Attachment:** **Level A**
Comments: Inspection verified 1/2" plywood roof deck attached with staples at a minimum of 6" on the edge & 12" in the field.

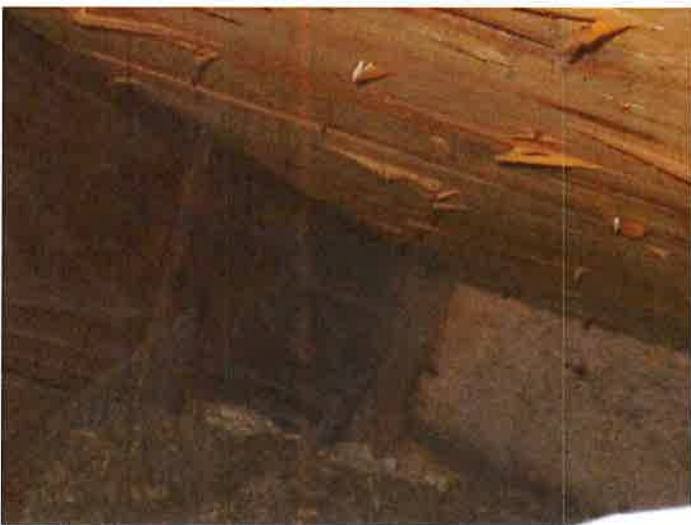
Roof to Wall Attachment
(Section 4)

4. **Roof to Wall Attachment:** **Clips**
Comments: Inspection verified embedded straps fastened with a minimum of three nails.
5. **Roof Geometry:** **Other Roof**
Comments: Inspection verified a gable roof shape.
