COMMERCIAL WINDSTORM MITIGATION REPORT (OIR-B1-1802)

Indian Springs Condominiums, Inc.

14800 Walsingham Rd, Building 1

As of 3/11/2020

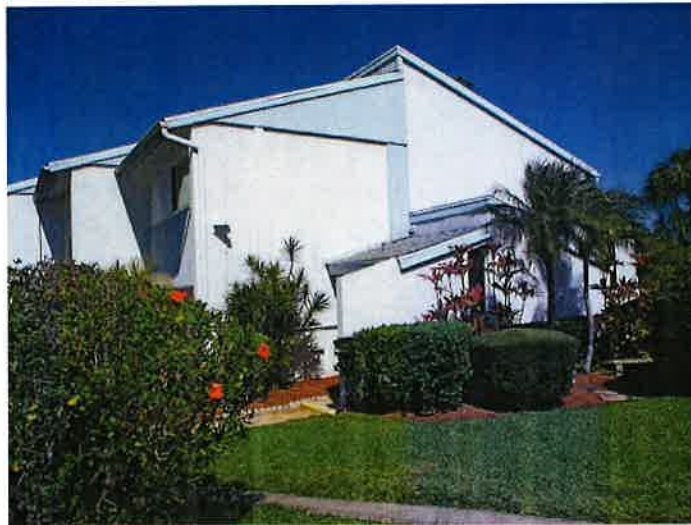
Exterior Elevation

4. **Roof to Wall Attachment:** **Clips**
Comments: Inspection verified embedded straps fastened with a minimum of three nails.
5. **Roof Geometry:** **Other Roof**
Comments: Inspection verified a gable roof shape.

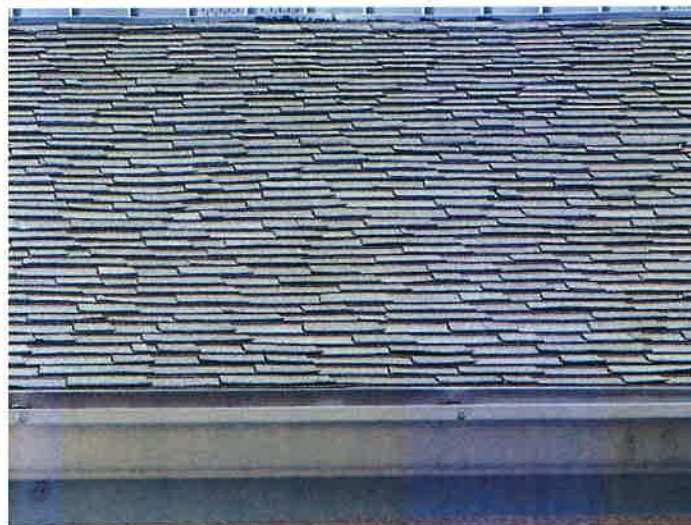
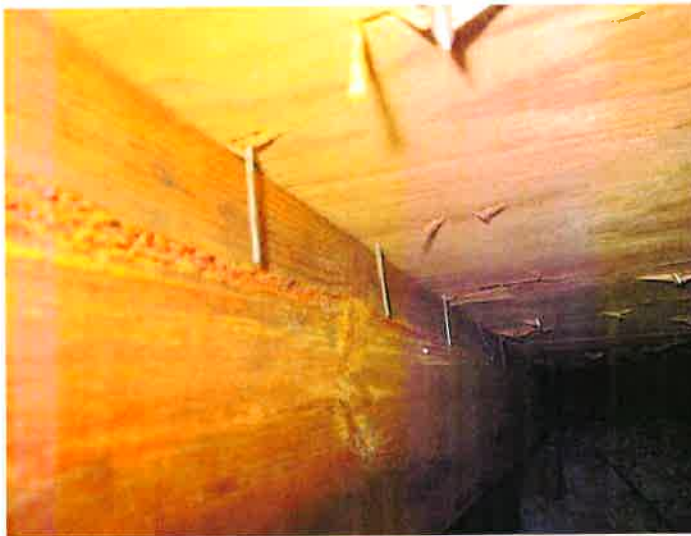
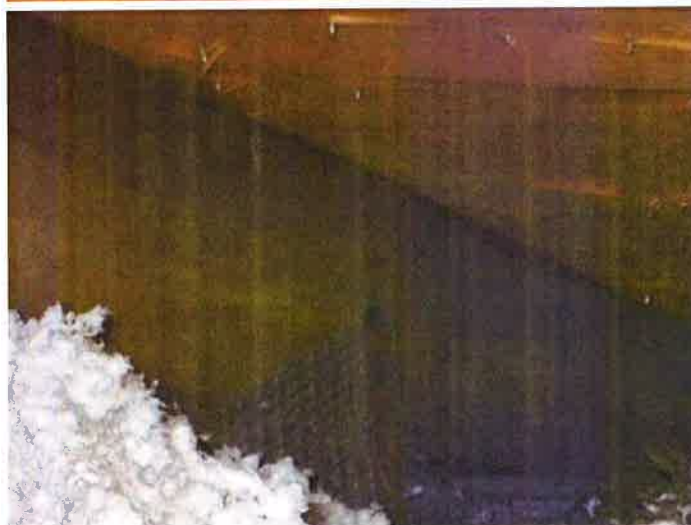
Roof Construction

3. **Roof Deck Attachment:** **Level A**
Comments: Inspection verified 1/2" plywood roof deck attached with staples at a minimum of 6" on the edge & 12" in the field.
