COMMERCIAL WINDSTORM MITIGATION REPORT (OIR-B1-1802)

Indian Springs Condominiums, Inc.

14800 Walsingham Rd, Building 12

As of 3/11/2020

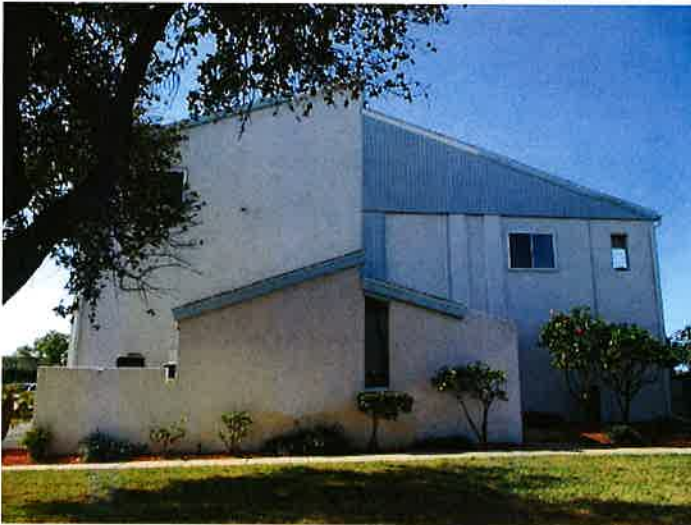
Exterior Elevation

4. **Roof to Wall Attachment:** **Clips**
Comments: Inspection verified embedded straps fastened with a minimum of three nails.
5. **Roof Geometry:** **Other Roof**
Comments: Inspection verified a gable roof shape.

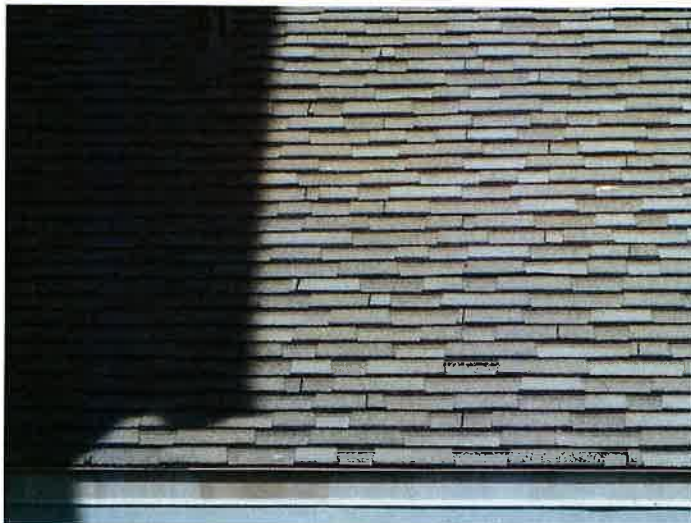
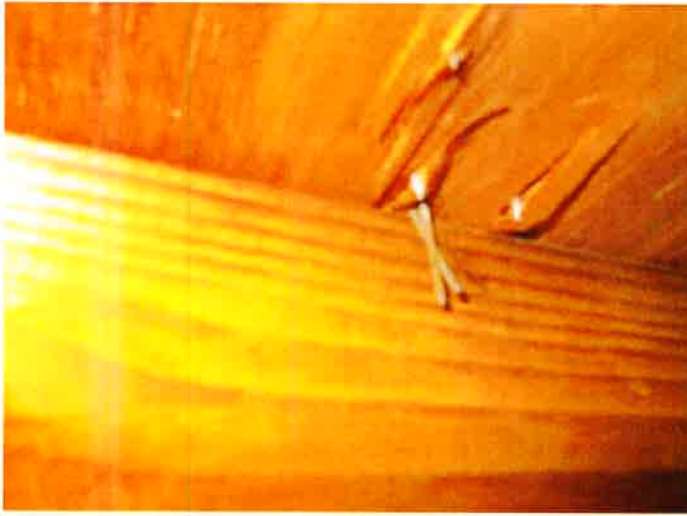
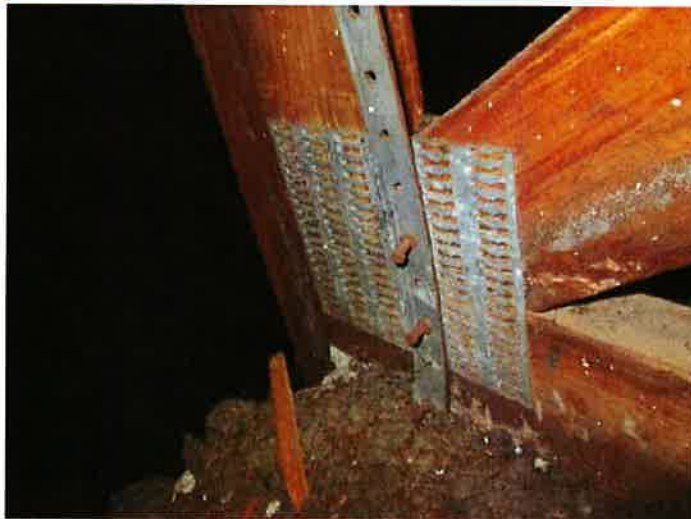
Roof Construction

3. **Roof Deck Attachment:** **Level A**
Comments: Inspection verified 1/2" plywood roof deck attached with staples at a minimum of 6" on the edge & 12" in the field.

6. **SWR:** **No**
Comments: Inspection verified no secondary water resistance.
7. **Opening Protection:** **None or Some Glazed Openings**
Comments: Inspection verified some metal shutter and vinyl opening protection. Not all glazed openings were protected with impact resistant coverings.
