COMMERCIAL WINDSTORM MITIGATION REPORT (OIR-B1-1802)

Indian Springs Condominiums, Inc.

14800 Walsingham Rd, Building 2

As of 3/11/2020

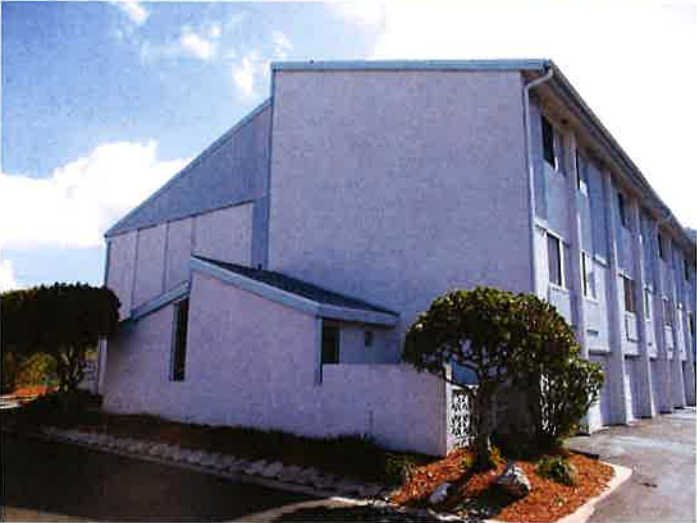
Exterior Elevation

- 4. Roof to Wall Attachment:** **Toe Nails**
Comments: Inspection verified embedded straps fastened with less than three nails.
- 5. Roof Geometry:** **Other Roof**
Comments: Inspection verified a gable roof shape.

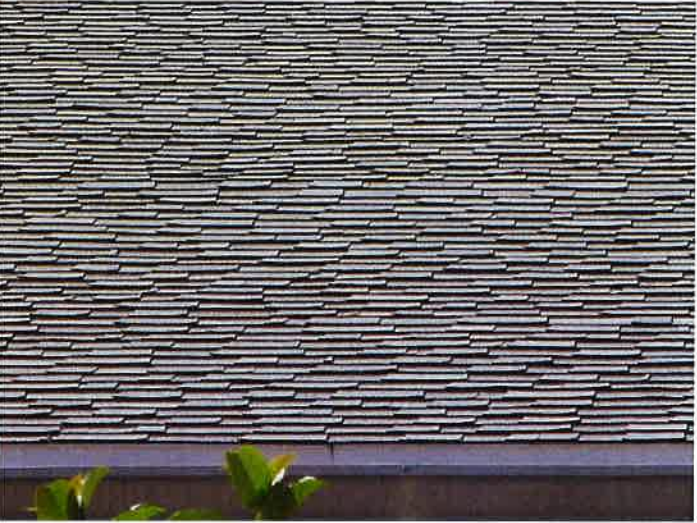
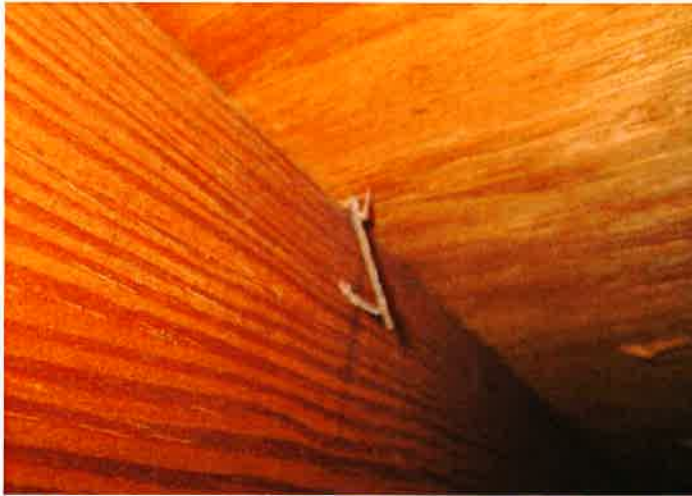
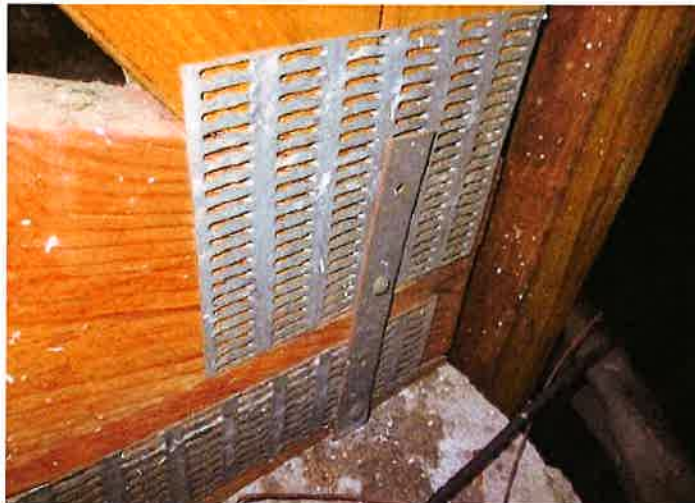
Roof Construction

- 3. Roof Deck Attachment:** **Level A**
Comments: Inspection verified 1/2" plywood roof deck attached with staples at a minimum of 6" on the edge & 12" in the field.
