COMMERCIAL WINDSTORM MITIGATION INSPECTION REPORT (OIR-B1-1802)

Indian Springs Condominium Association Inc

14800 Walsingham Rd (Building 3)

RECAPITULATION OF MITIGATION FEATURES
For 14800 Walsingham Rd (Building 3)

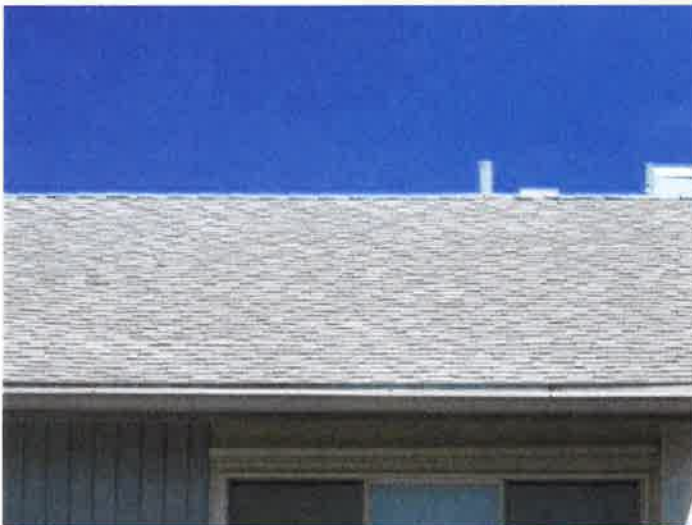
Roof Covering (Section 2)

2. **Roof Covering:** **FBC Equivalent**
Comments: According to association records the roof covering was replaced 2005. We were unable to locate a roofing permit with the local building department; however, in our professional opinion the roof covering was replaced in 2005. The roof covering replacement was confirmed via historical imagery provided by Google Earth and information provided by the association.

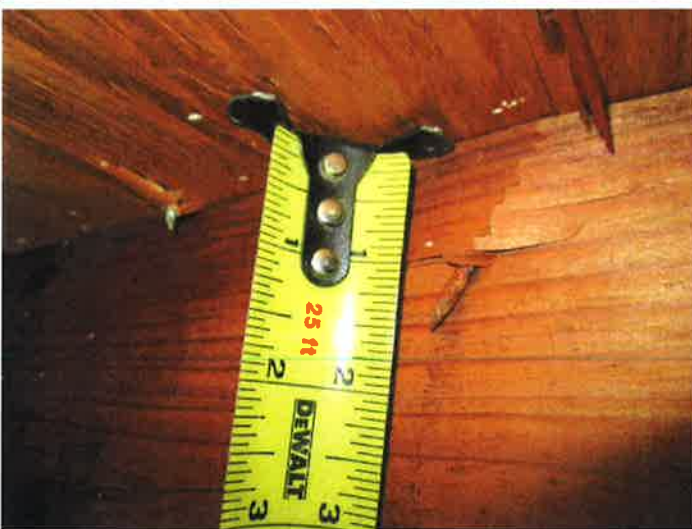
Roof Deck Attachment
(Section 3)

3. **Roof Deck Attachment:** **Level A**
Comments: Inspection verified 1/2" plywood roof deck attached with 6d nails at a minimum of 6" on the edge & 12" in the field.

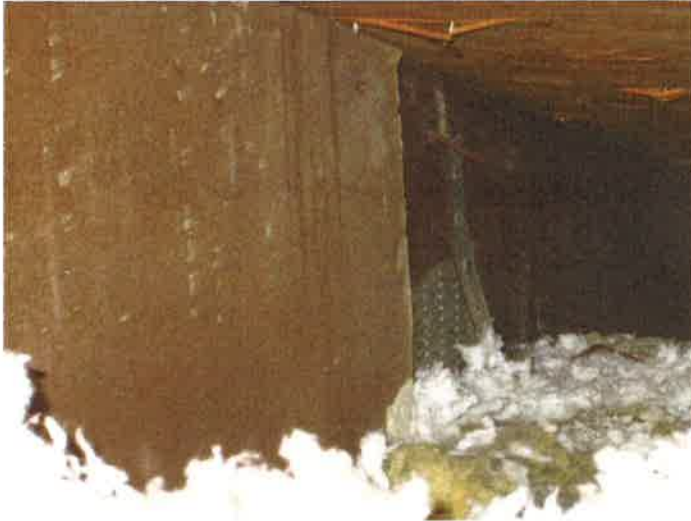
Roof to Wall Attachment
(Section 4)

4. **Roof to Wall Attachment:** **Toe Nails**
Comments: Inspection verified embedded straps fastened with less than three nails.

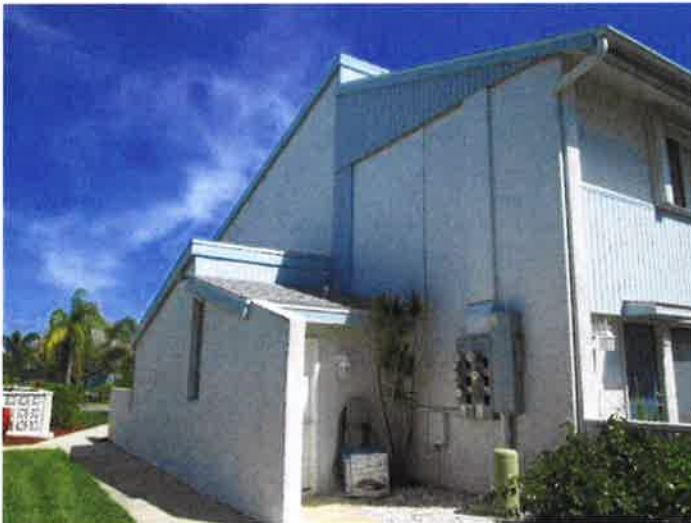
Roof Shape (Section 5)

5. **Roof Geometry:** **Other Roof**
Comments: Inspection verified a gable roof shape.
