## COMMERCIAL WINDSTORM MITIGATION REPORT (OIR-B1-1802)

Indian Springs Condominiums, Inc.

14800 Walsingham Rd, Building 5

As of 3/11/2020

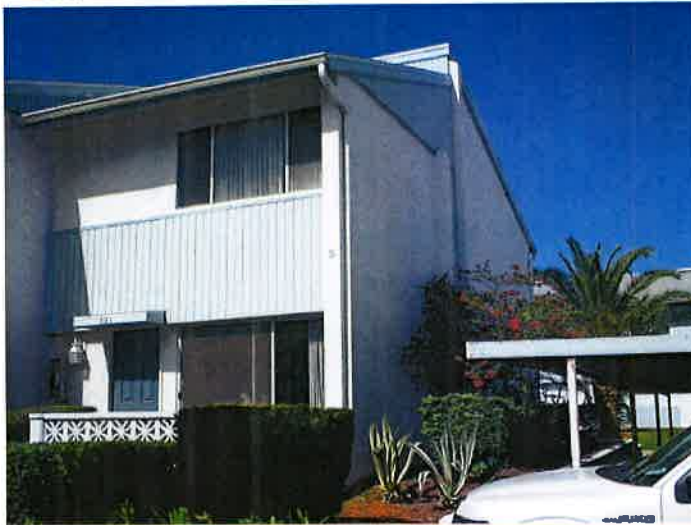
Exterior Elevation

- 5. Roof Geometry:**                      **Other Roof**  
Comments:                                      Inspection verified a gable roof shape.
- 6. SWR:**                                      **No**  
Comments:                                      Inspection verified no secondary water resistance.

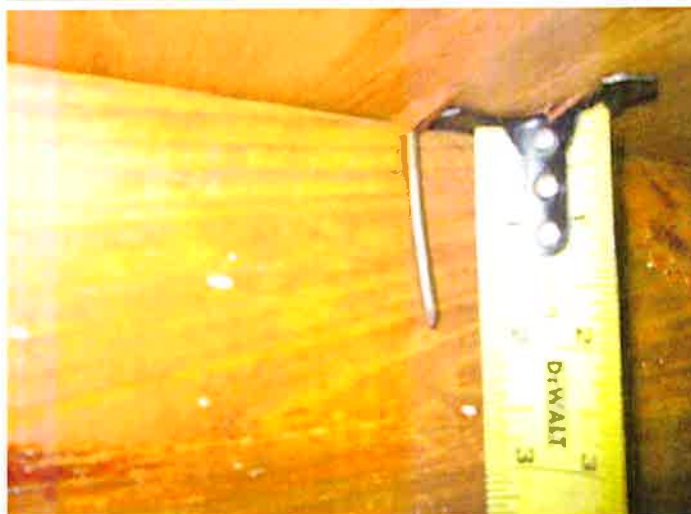
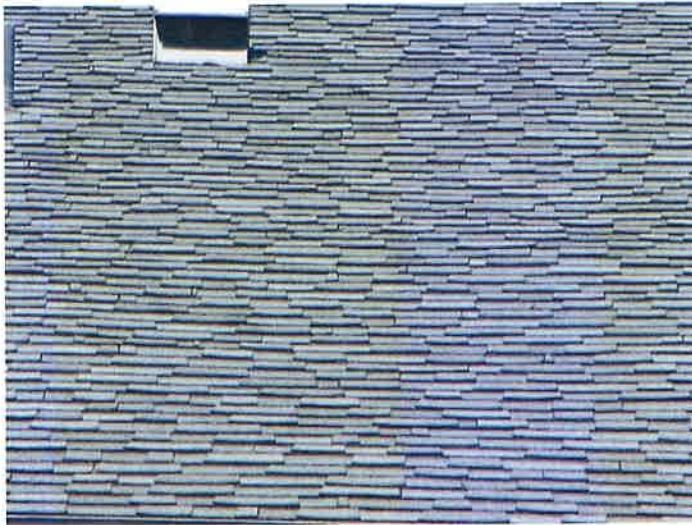
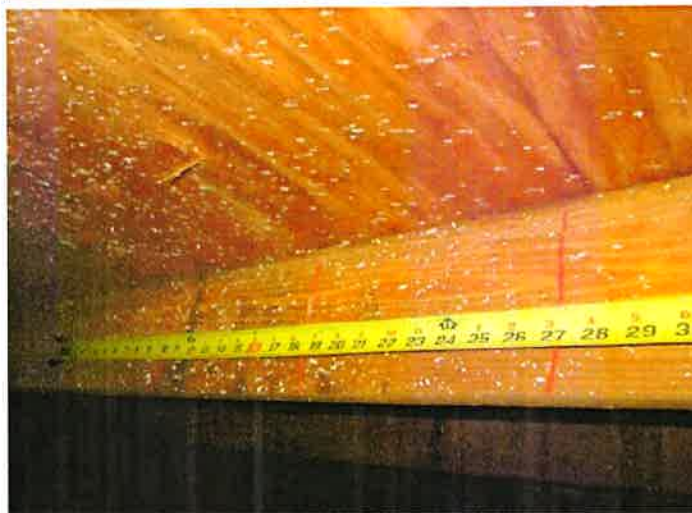
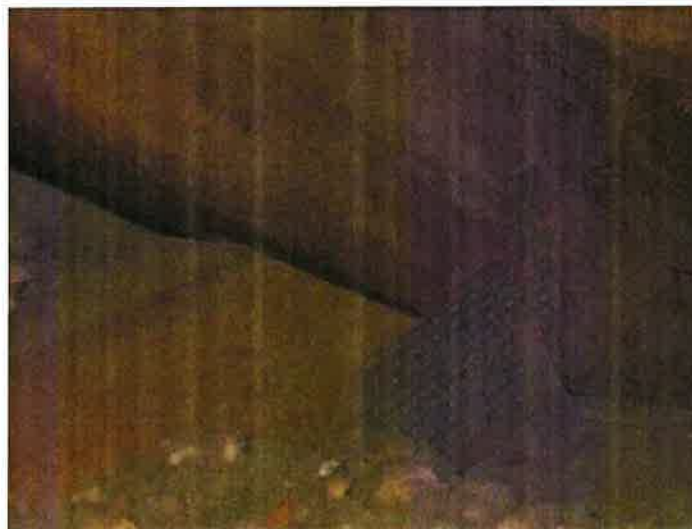
Roof Construction

- 3. Roof Deck Attachment:**        **Level B**  
Comments:                                      Inspection verified 1/2" plywood roof deck attached with 8d nails at a minimum of 6" on the edge & 12" in the field.

- 4. Roof to Wall Attachment:**        **Toe Nails**  
Comments:                                      Inspection verified embedded straps fastened with less than three nails.
